**Degradation of Peel and Tensile
Strength of Bonded Panels
Exposed to High Humidity**

DSTO-TR-1272

**Airframes and Engines Division
Aeronautical and Maritime Research Laboratory**

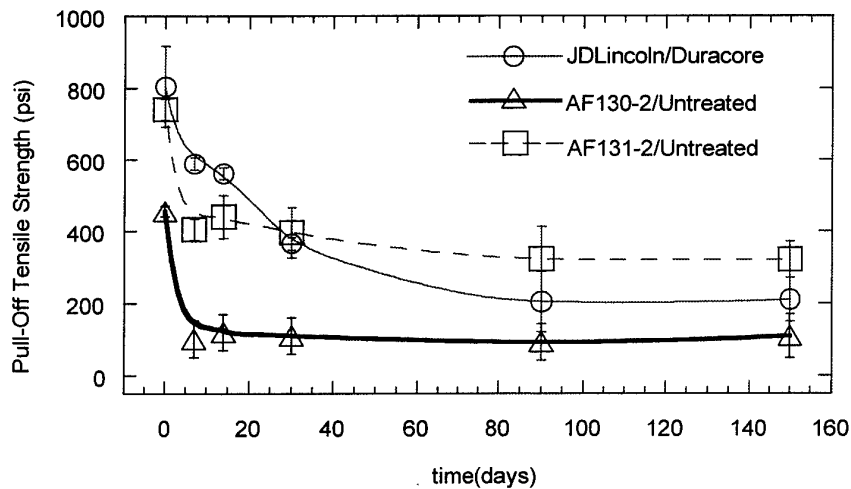
Figure 1 Honeycomb panel tensile strength as a function of exposure to a 70°C/100% R.H. environment.

The data in Figure 1 indicates that direct exposure of the fillet bonds to moisture results in a significant reduction in the tensile strength of the honeycomb sandwich panel bonds and a significant increase in adhesion failure. In all cases the majority of the strength reduction and adhesion failure occurs within 30 days. This suggests that should moisture gain access to the bonded honeycomb panel on an aircraft that the reduction in panel tensile strength would be quite rapid. In the case of the AF131-2, the reduction in strength wasn't as marked as the other two systems examined and the percentage of adhesion failure was not as marked. AF-131-2 is used in higher temperature applications on the aircraft and subtle differences in epoxy resin chemistry may improve the adhesive bond formation process during panel fabrication. Generally, the bonded panel tensile strength appears to be inversely proportional to the percentage of adhesion failure and is directly related to moisture diffusing to the adhesive and honeycomb interfacial region and displacing the adhesive bonds from the aluminium honeycomb core surface.

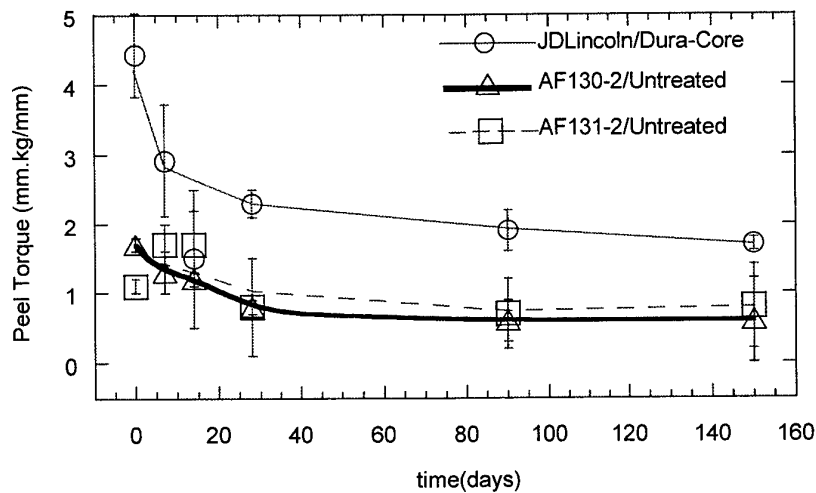
Figure 2 Honeycomb panel peel strength as a function of exposure to a 70°C/100% R.H. environment.

The data in Figure 2 indicates that the change in peel strength for the different honeycomb-adhesive combinations is not as marked as in the tensile strength case. The adhesives tested, particularly the AF-130-2 and AF131-2 adhesives, are brittle and the lack of fracture toughness is shown by the low peel strength values. The newer JD-Lincoln adhesive, shows higher peel resistance, but degrades rapidly in strength once exposed to the moist environment. Both the AF130-2 and JD Lincoln samples indicated that peel strength reduction was associated with a significant increase in adhesion failure either at the skin to adhesive interface or the honeycomb core to adhesive interface. The AF131-2, in contrast, showed a percentage of cohesive fracture of the fillet bond adhesive even after extended exposure, without significant changes in peel strength being observed. The recorded failure modes will provide an important reference for the type of fracture surfaces that will indicate adhesive bond degradation in bonded panels being inspected on the F-111 teardown article in Task Air 00/140.

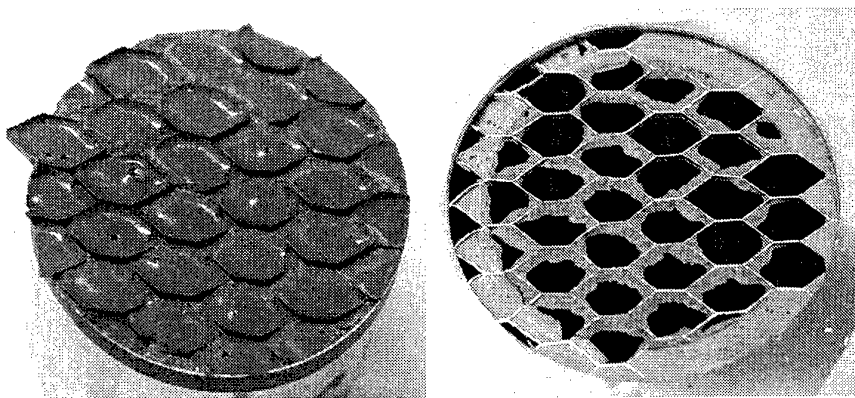
Figure 3 Failure surfaces resulting from tensile testing of the Dura-Core honeycomb and JD Lincoln adhesive control specimen, indicating a mixture of cohesive failure and fillet bond pull-out.

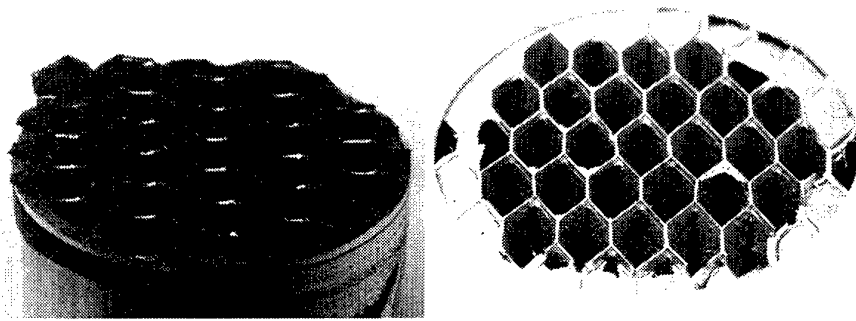
Figure 4 Failure surfaces resulting from tensile testing of the Dura-Core honeycomb and JD Lincoln adhesive conditioned 30 days at 70°C/100% R.H., indicating fillet bond pull-out.

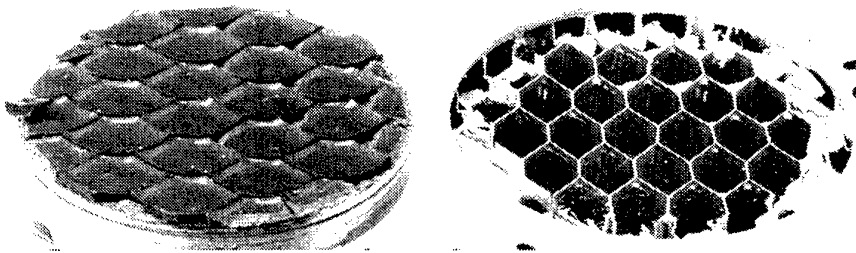
Figure 5 Failure surfaces resulting from tensile testing of the Dura-Core honeycomb and JD Lincoln adhesive conditioned 150 days at 70°C/100% R.H., indicating fillet bond pull-out.

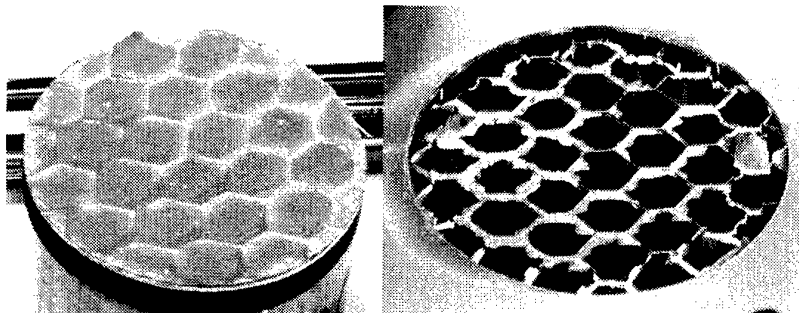
Figure 6 Failure surfaces resulting from tensile testing of the Untreated honeycomb and AF130-2 adhesive control specimen, indicating a mixture of cohesive failure and fillet bond pull-out.

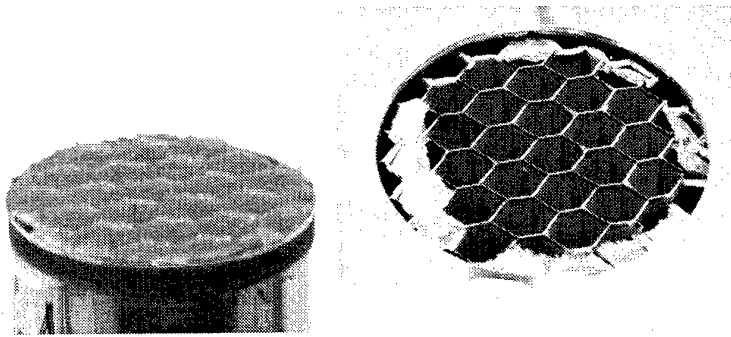
Figure 7 Failure surfaces resulting from tensile testing of the Untreated honeycomb and AF130-2 adhesive conditioned 30 days at 70°C/100%R.H., indicating fillet bond pull-out.

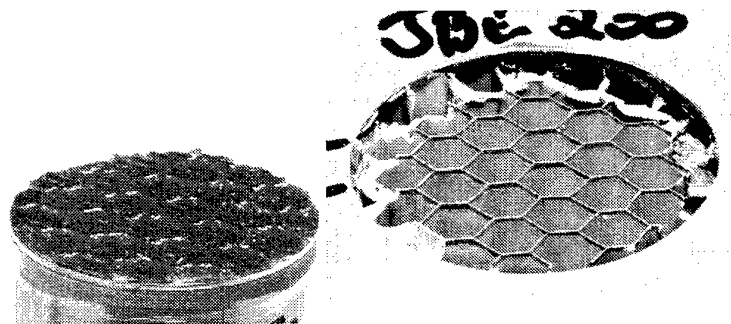
Figure 8 Failure surfaces resulting from tensile testing of the Untreated honeycomb and AF130-2 adhesive conditioned 150 days at 70°C/100%R.H., indicating fillet bond pull-out.

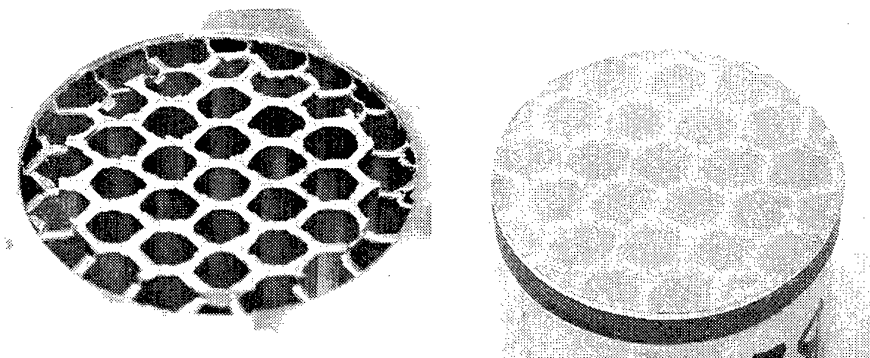
Figure 9 Failure surfaces resulting from tensile testing of the Untreated honeycomb and AF131-2 adhesive control specimen, indicating cohesive fillet bond failure.

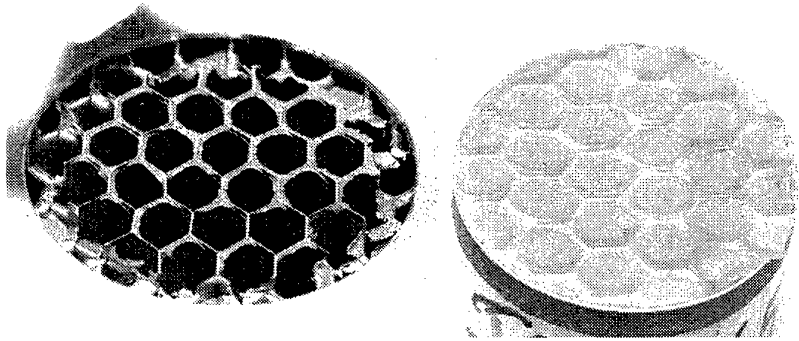
Figure 10 *Failure surfaces resulting from tensile testing of the Untreated honeycomb and AF131-2 adhesive conditioned 30 days at 70°C/100%R.H., indicating fillet bond pull-out and cohesion failure.*

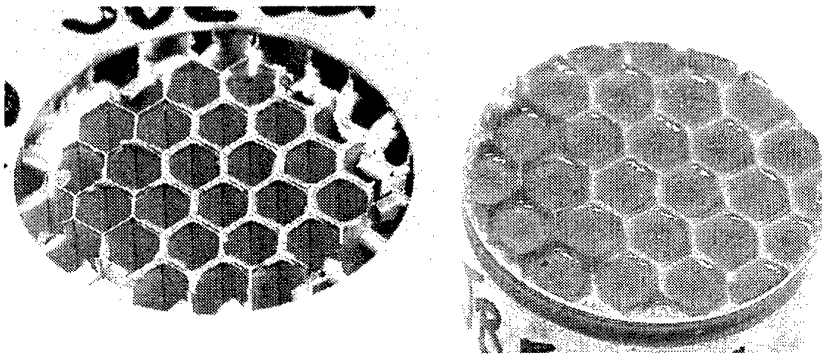
Figure 11 *Failure surfaces resulting from tensile testing of the Untreated honeycomb and AF131-2 adhesive conditioned 150 days at 70°C/100%R.H., indicating fillet bond pull-out and cohesion failure.*

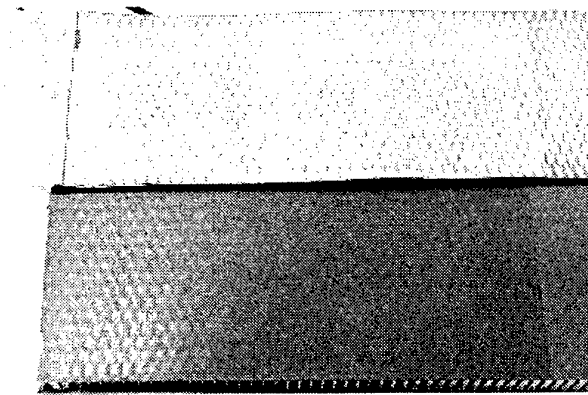
Figure 12 Failure surfaces resulting from peel testing of the Dura-Core honeycomb and JD Lincoln adhesive control specimen, indicating a mixture of cohesive failure and skin to adhesive failure.

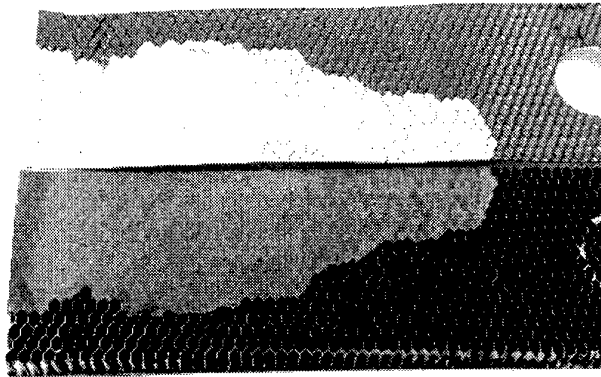
Figure 13 Failure surfaces resulting from peel testing of the Dura-Core honeycomb and JD Lincoln adhesive conditioned 30 days at 70°C/100% R.H., indicating fillet bond pull-out and skin to adhesive failure.

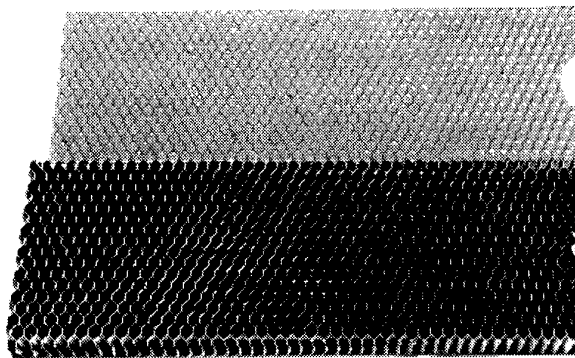
Figure 14 Failure surfaces resulting from peel testing of the Dura-Core honeycomb and JD Lincoln adhesive conditioned 150 days at 70°C/100% R.H., indicating fillet bond pull-out.

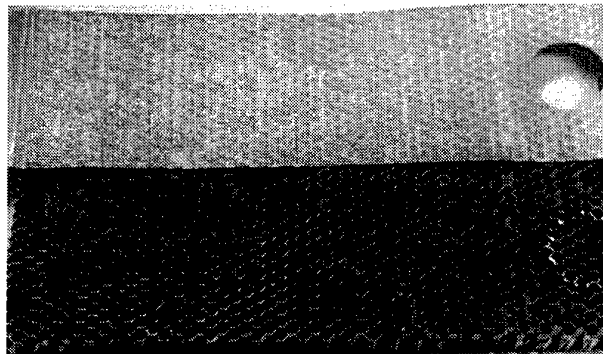
Figure 15 Failure surfaces resulting from peel testing of Untreated honeycomb and AF130-2 adhesive control specimen, indicating a mixture of cohesive failure and skin to adhesive failure.

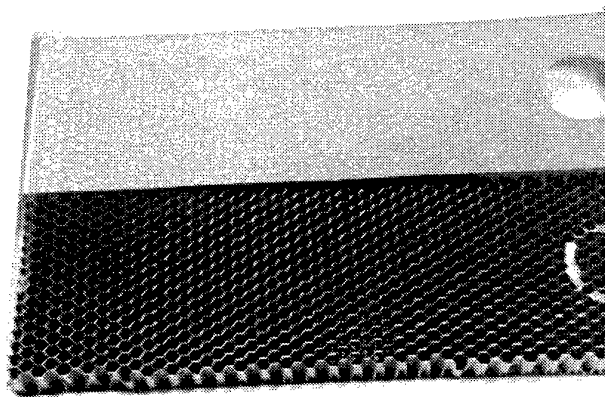
Figure 16 Failure surfaces resulting from peel testing of the Untreated honeycomb and AF130-2 adhesive conditioned 30 days at 70°C/100%R.H., indicating fillet bond pull-out.

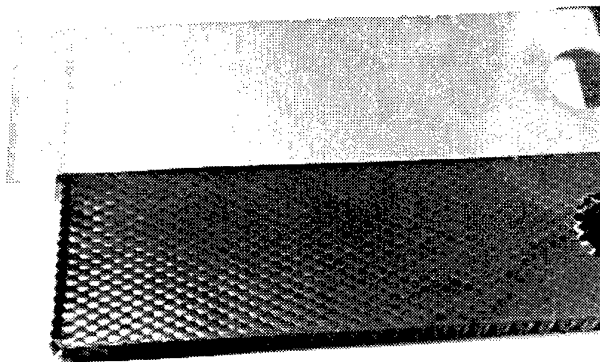
Figure 17 Failure surfaces resulting from peel testing of the Untreated honeycomb and AF130-2 adhesive conditioned 150 days at 70°C/100%R.H., indicating skin to adhesive disbond.

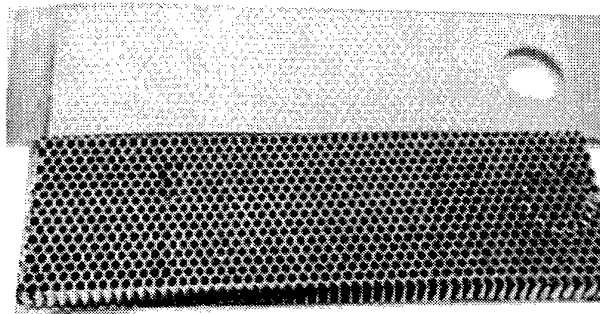
Figure 18 Failure surfaces resulting from peel testing of Untreated honeycomb and AF131-2 adhesive control specimen, indicating a mixture of cohesive failure and skin to adhesive failure.

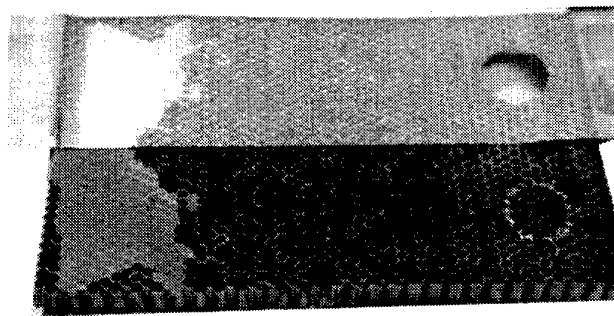
Figure 19 Failure surfaces resulting from peel testing of the Untreated honeycomb and AF131-2 adhesive conditioned 30 days at 70°C/100%R.H., indicating fillet bond pull-out, cohesion failure and skin adhesive disbond.

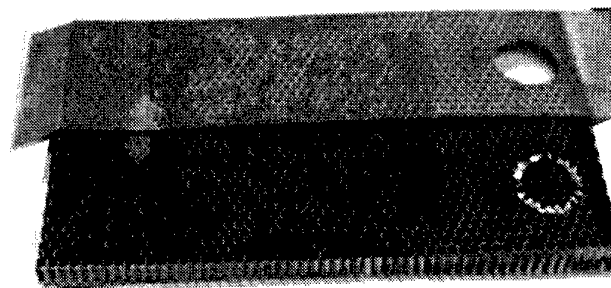
Figure 20 Failure surfaces resulting from peel testing of the Untreated honeycomb and AF131-2 adhesive conditioned 150 days at 70°C/100%R.H., indicating fillet bond pull-out and cohesion failure.

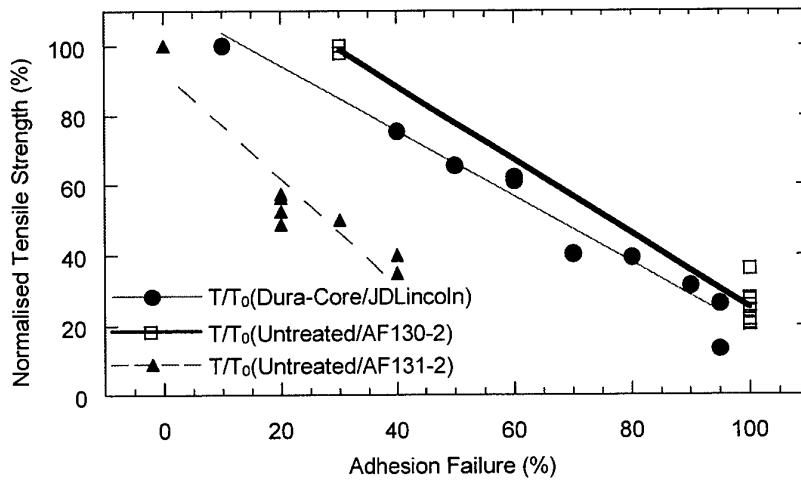
Figure 21 and Figure 22 indicate the measured tensile and peel strength as a function of adhesion failure for the three different honeycomb/adhesive systems. The results suggest that there is an inverse linear relationship between the mechanical strength and the percentage of adhesion failure. Surprisingly, both figures indicate that residual strength remains even when there is 100% adhesion failure. This result may suggest that the mode of failure is caused by moisture diffusion between the adhesive and metal surface of the core or skin material displacing adhesive bonds. The residual strength may indicate that there are still some adhesive bonds that are not disrupted by the interfacial water.

Figure 21 Normalised tensile strength as a function of adhesion failure

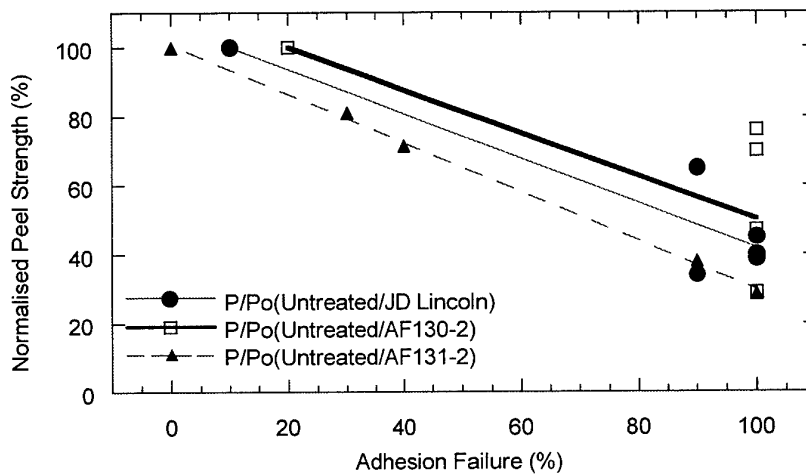
Figure 22 Normalised peel strength as a function of adhesion failure

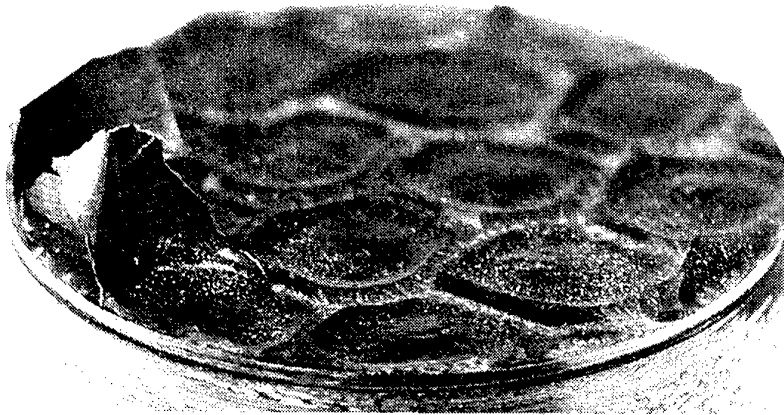
Figure 27 Failure surface of the portable adhesion test stub taken from the Stab-Tip after immersion in 50°C ionised water for 13 months, indicating regions of fillet bond pull-out.

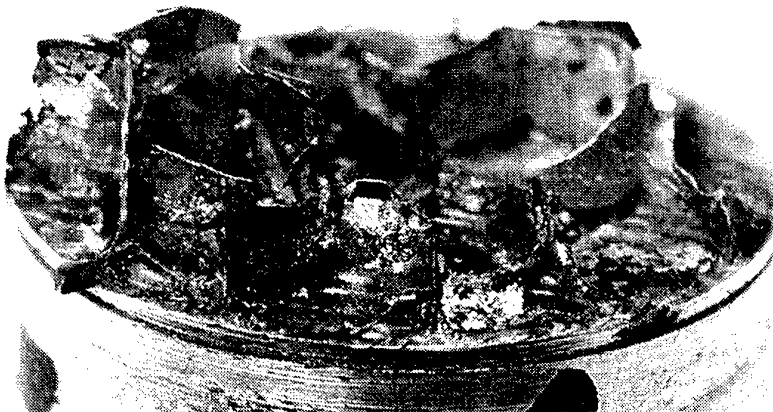
Figure 28 Failure surface of the portable adhesion test stub taken from the Stab-Tip after immersion in 50°C ionised water for 13 months, indicating regions of core corrosion leading to core fracture.

number of holes in the panel being present. In one location moisture ingress into the core had led to corrosion and consequent failure during tensile loading. However, in the majority of cases a mixture of cohesive fillet bond fracture and core fracture was observed. This mode is typically observed for the lighter gauge core material used to fabricate the Stab-Tip panel.

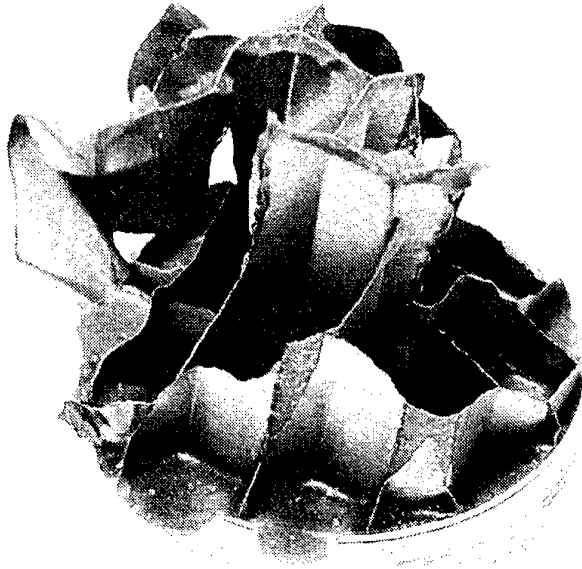
Figure 29 *Failure surface of the portable adhesion test stub taken from the Stab-Tip prior to immersion in 50°C ionised water, indicating regions of honeycomb core fracture.*

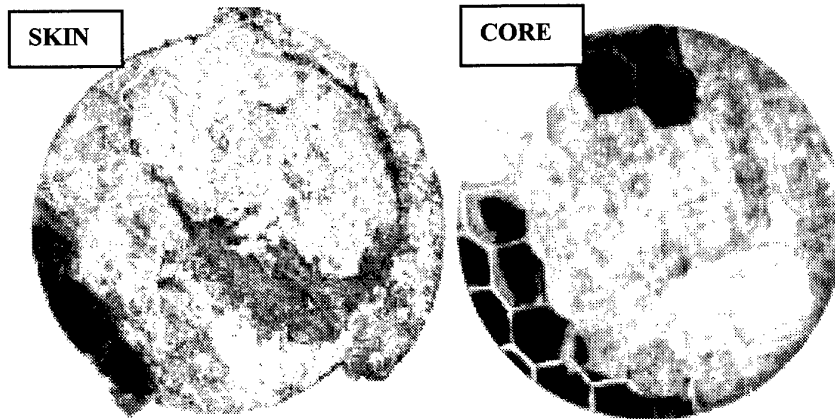
Figure 31 Failure surface images from the tensile test taken in location 4, refer Table 3, of the Sta-Tip Cap where skin to adhesive corrosion has degraded the honeycomb panel strength.

The Stab-Tip Cap indicated an area where significant strength reduction was caused by corrosion between the fillet adhesive and aluminium skin. This example of corrosion failure suggests that regions susceptible to moisture ingress on bonded panels should be considered carefully during routine aircraft maintenance and inspection. NDI of the Stab-Tip Cap also suggested that the Tap-Hammer test is potentially difficult to apply in a consistent and reliable manner to identify disbanded panel regions. The area identified by the Tap-Hammer test indicated Tensile strength values were normal. The Stab-Tip Cap inspection also highlighted the deficiency in the use of injection repairs. The reduction in tensile strength and observation of the failure mode suggested that the injected potting compound had not adequately wetted the core and skin, leading to a weak adhesive bond. The low strength value recorded also suggested that strength of the potting compound was low, as indicated by regions where the potting compound had fractured cohesively.

- 2) Due to the poor durability of honeycomb sandwich panels that have been rebuilt or repaired using either AF-130-2, AF131-2 or JD Lincoln adhesive and Alcore Duracore or Untreated honeycomb, special attention should be given to ensuring perimeters of panels are carefully sealed to prevent any moisture ingress.

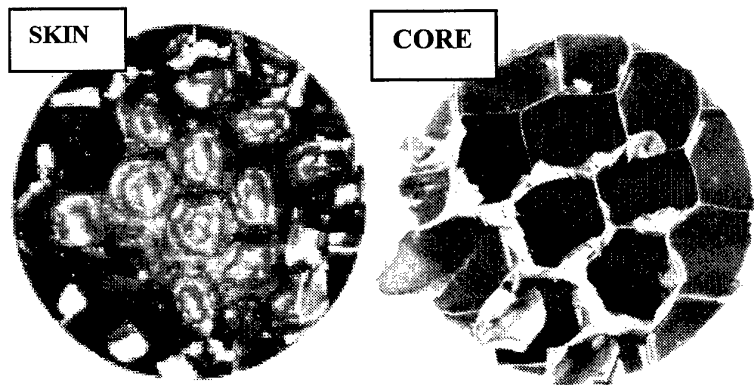
Figure 32 Failure surface images from the tensile test taken in location 3, refer Table 3, of the Sta-Tip Cap, where an ineffective injection repair has degraded the honeycomb panel strength.

- 3) During inspection and maintenance, regions of panels containing old or existing injection repairs should be carefully inspected for potential disbonds and corrosion.
